Incident Report on Service Disruption on 3 April 2015

China Unicom (Hong Kong) Operations Limited

Incident Report on Service Disruption on 5 April 2015

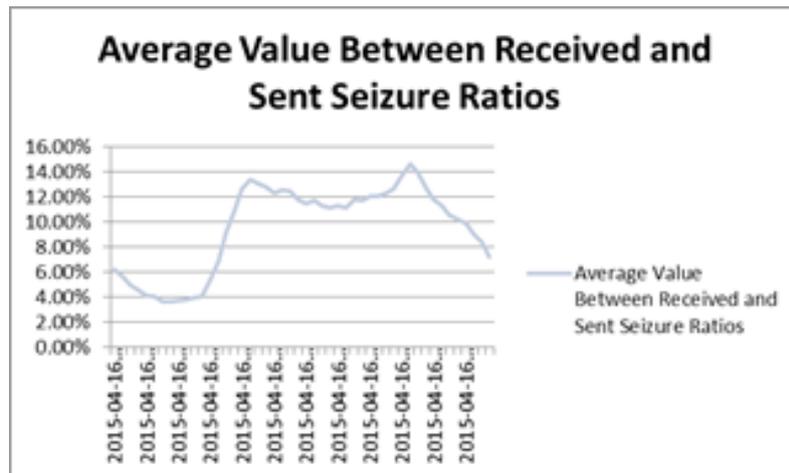
7.3 ¹⁷According to the statistics of the signalling links in the diagram below, the seizure ratio was 14.63% only.

7.2 The number of signalling links of the HLR system had been expanded¹⁶.

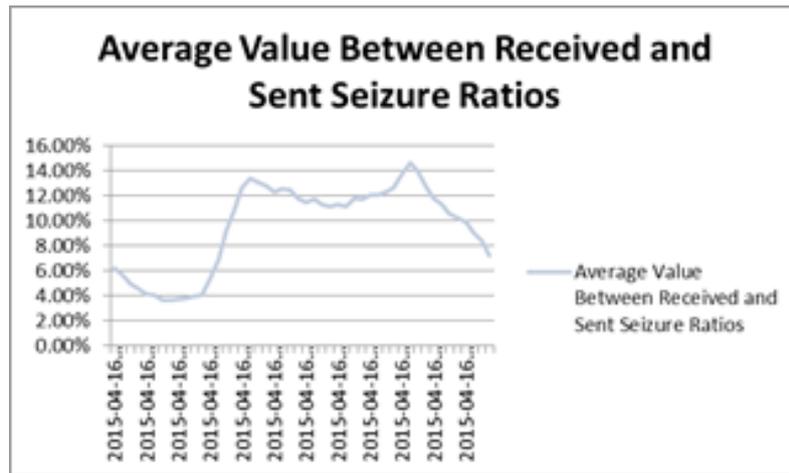
- 7.3 ¹⁸According to the statistics of the signalling links between HLR and CNP in the diagram below, the seizure ratio was 14.63% only.

- 7.1 We have implemented the following measures to prevent occurrence of similar incident in the future:
- increased the number of signal links; and
 - closely monitoring of the HLR system.
