## 北潭郊遊徑流動電話網絡接收情況

### Mobile Network Coverage along Pak Tam Country Trail

圖則編號 **Plan No. OFCA/23**  
二零二一年八月版 August 2021 Edition

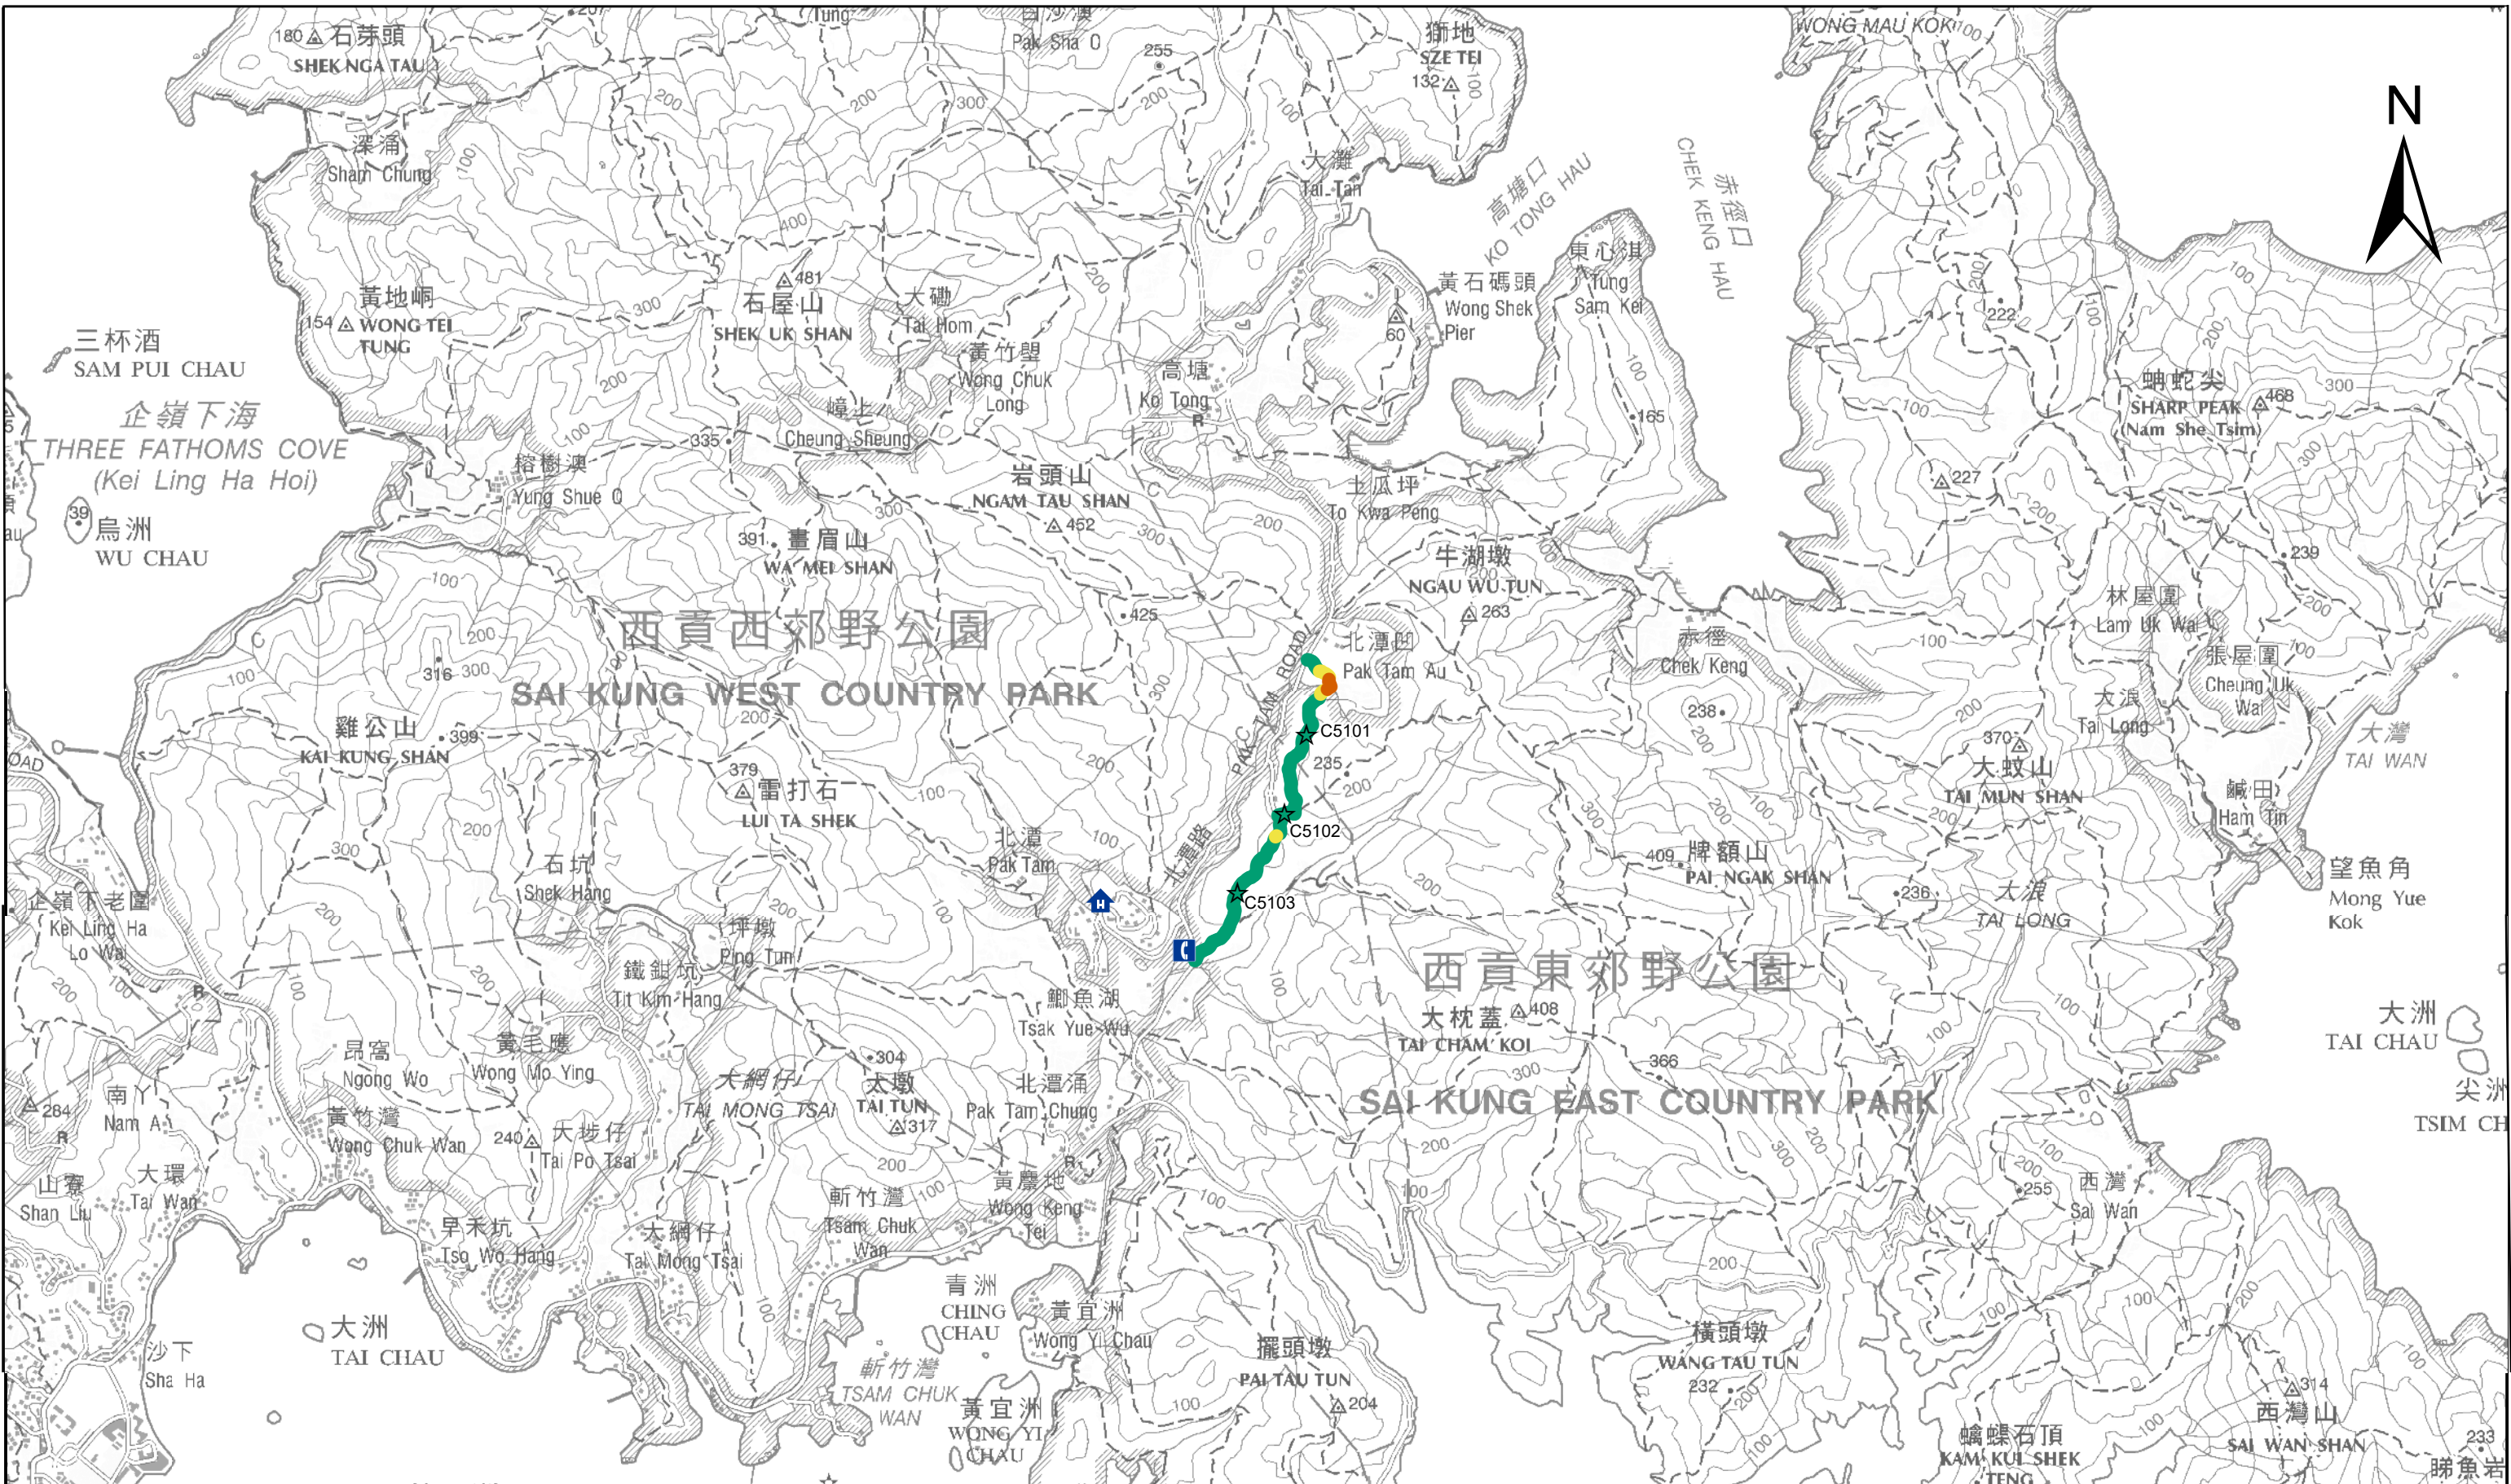
● 可以接駁到一個或以上本地網絡而話音質素良好  
 Calls could be connected to one or more local network(s) and voice quality was good

● 可以接駁到一個或以上本地網絡而話音質素欠佳  
 Calls could be connected to one or more local network(s) but voice quality was poor

● 未能接駁到任何本地網絡  
 Calls could not be connected to any local network

量度日期 **Measurement Date:**  
二零二零年九月  
September 2020
