## 大潭郊遊徑流動電話網絡接收情況

### Mobile Network Coverage along Tai Tam Country Trail

圖則編號 Plan No. OFCA/38  
 二零二一年八月版 August 2021 Edition

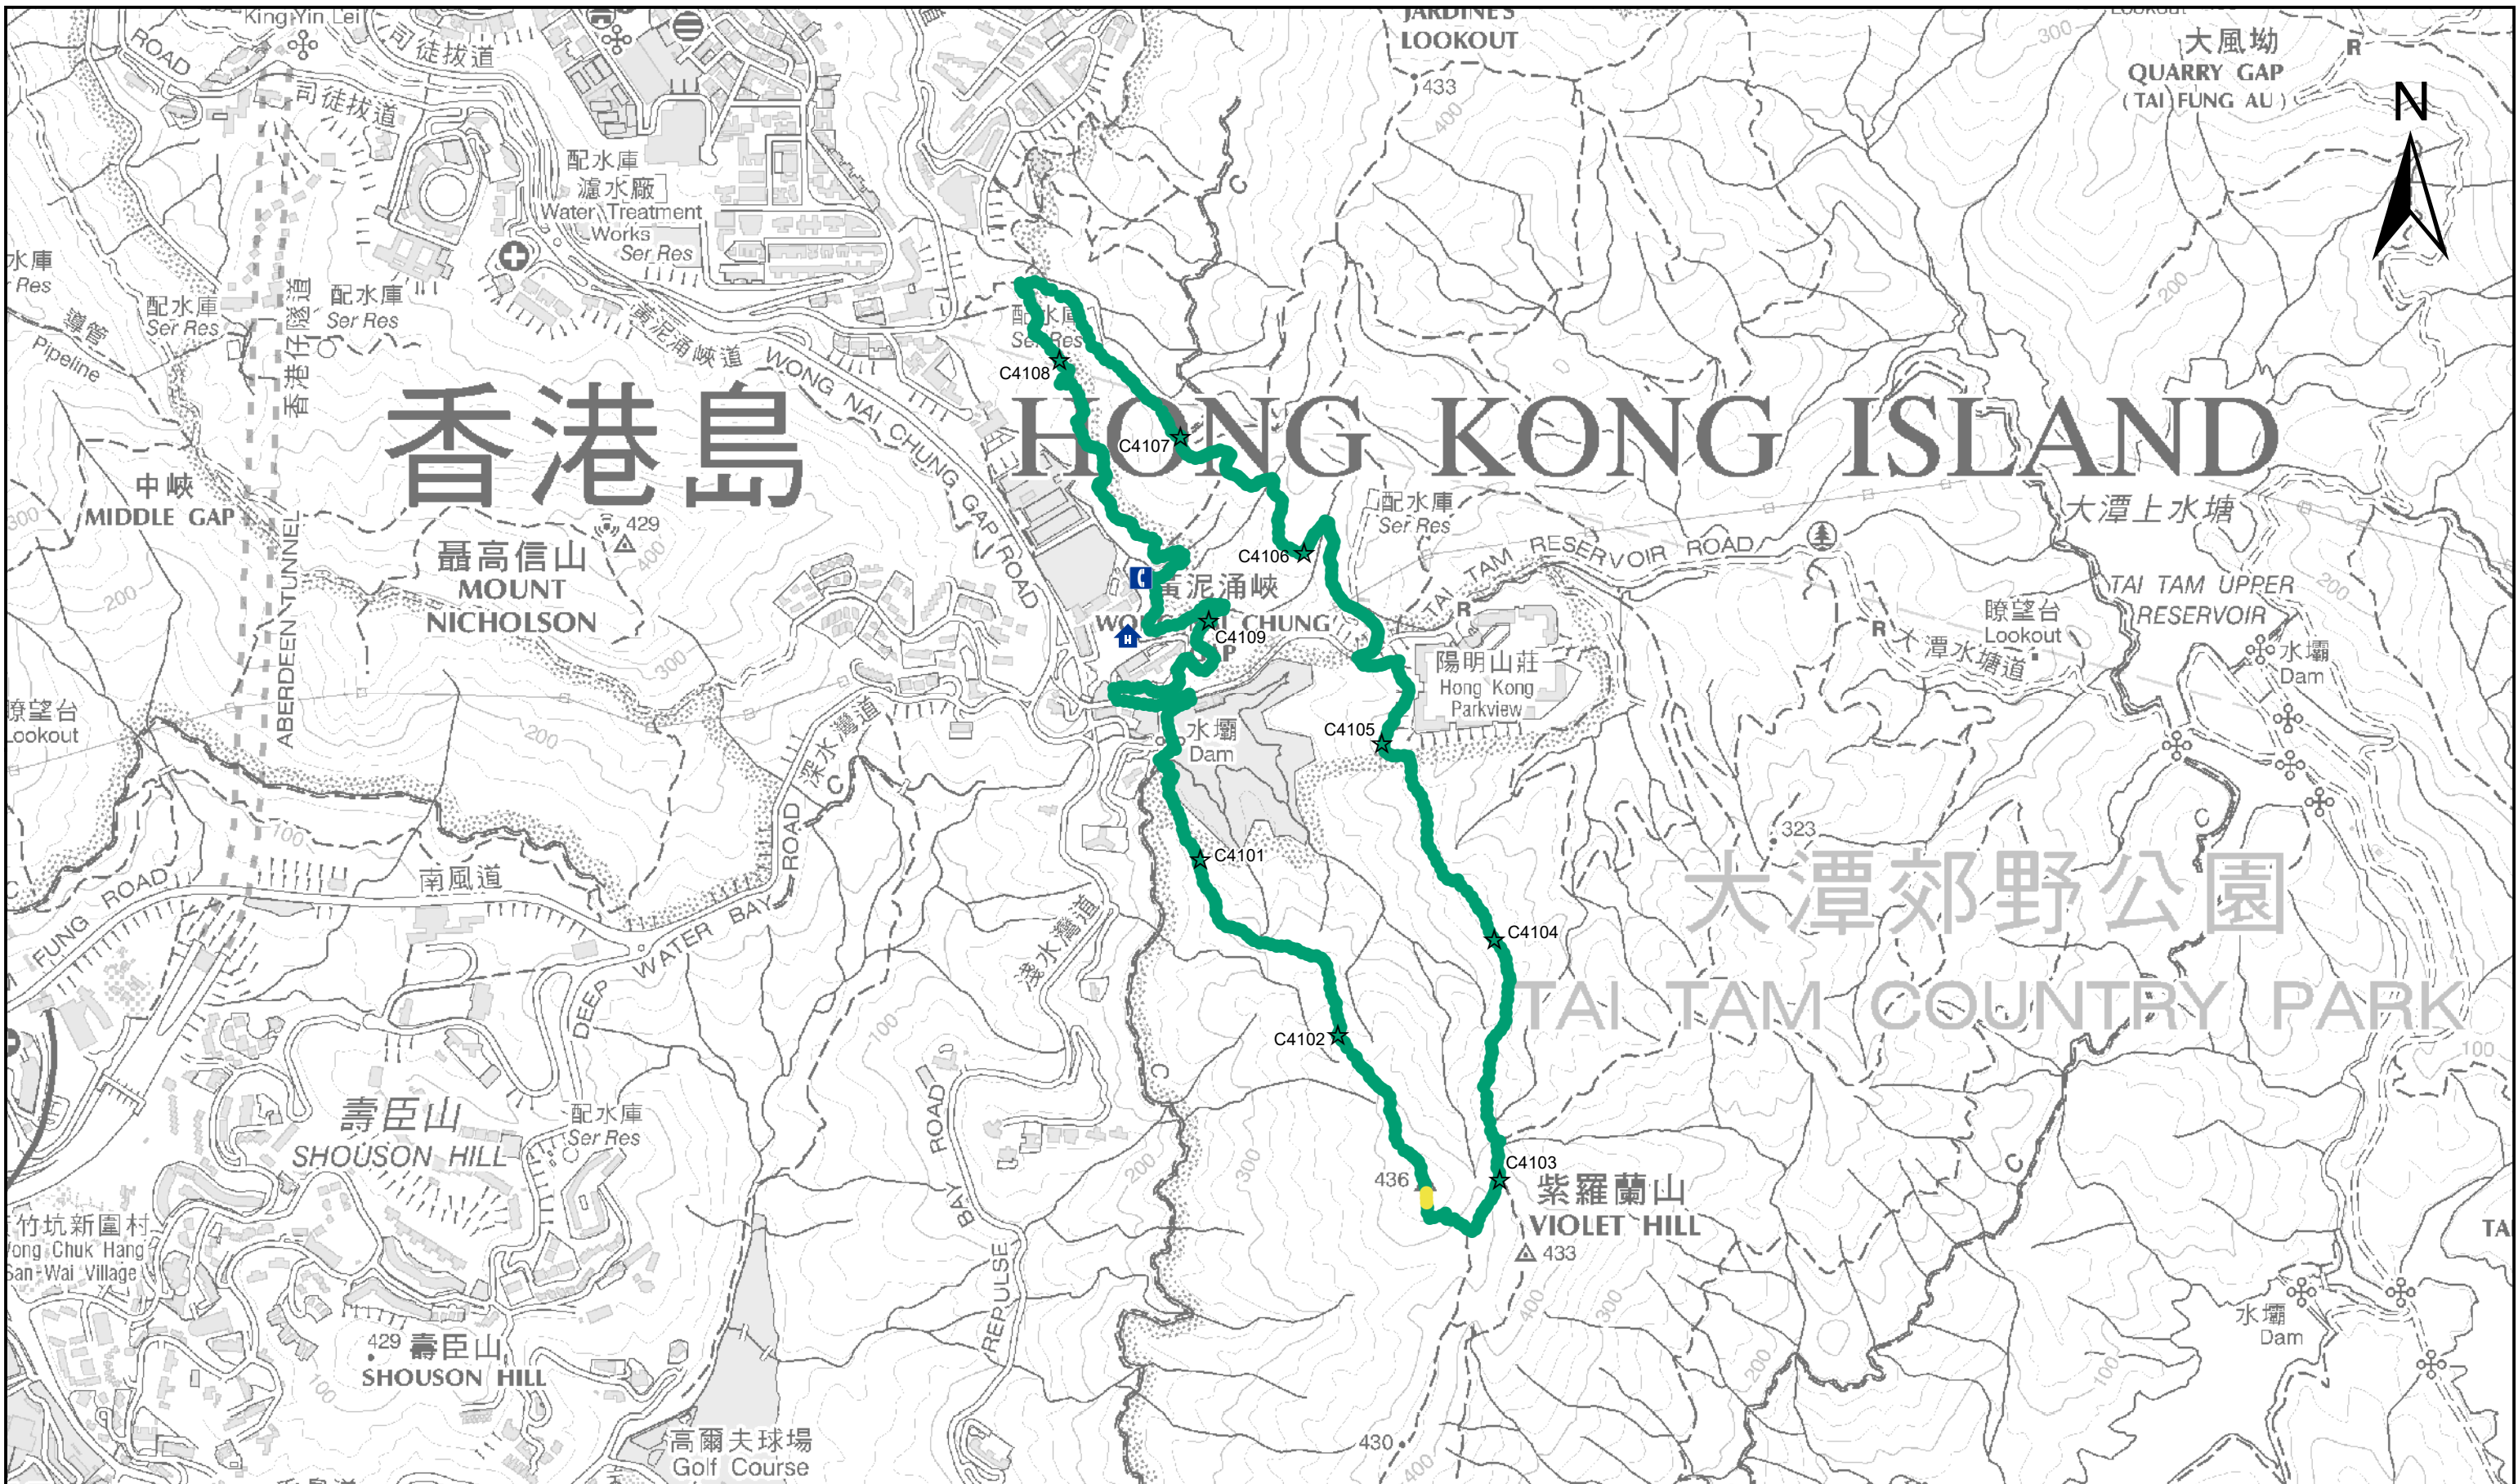
● 可以接駁到一個或以上本地網絡而話音質素良好  
 Calls could be connected to one or more local network(s) and voice quality was good

● 可以接駁到一個或以上本地網絡而話音質素欠佳  
 Calls could be connected to one or more local network(s) but voice quality was poor

● 未能接駁到任何本地網絡  
 Calls could not be connected to any local network

量度日期 Measurement Date:  
 二零二零年六月  
 June 2020
