梅窩至大蠔灣流動電話網絡接收情況

Mobile Network Coverage from Mui Wo to Tai Ho Wan

圖則編號 Plan No. **OFCA/54**
二零二一年八月版 August 2021 Edition

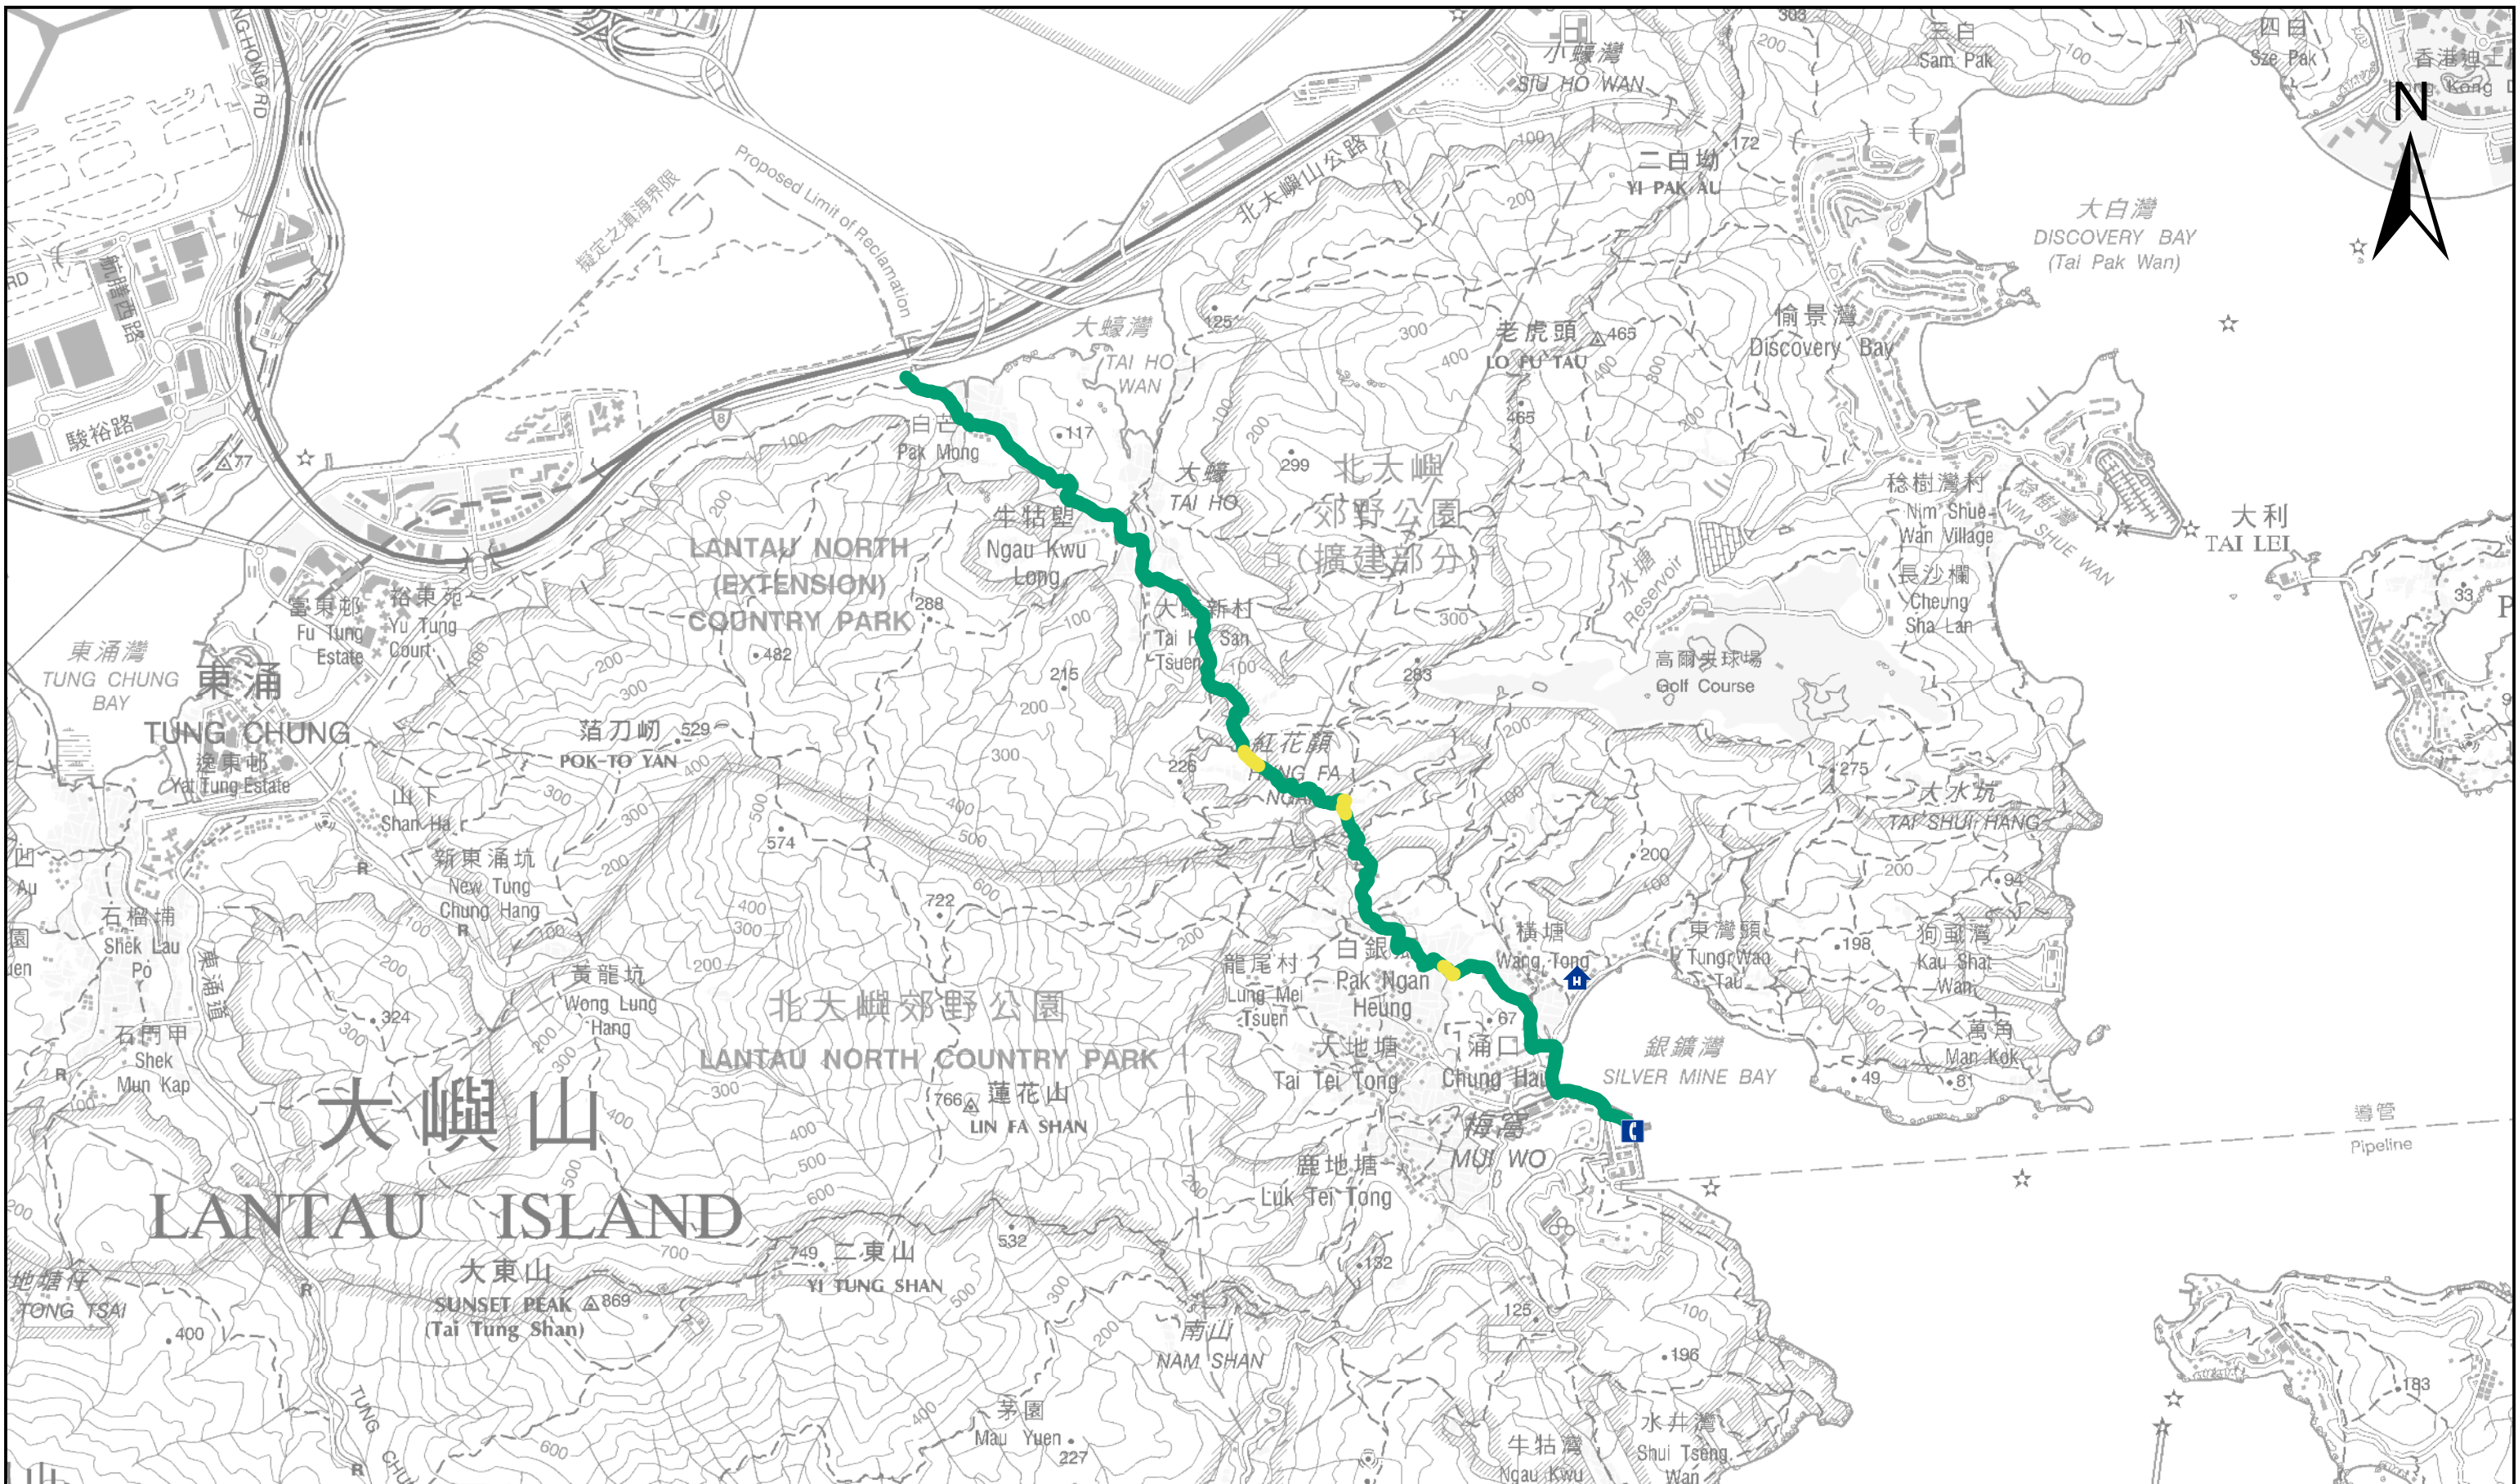
可以接駁到一個或以上本地網絡而話音質素良好
Calls could be connected to one or more local network(s) and voice quality was good

可以接駁到一個或以上本地網絡而話音質素欠佳
Calls could be connected to one or more local network(s) but voice quality was poor

未能接駁到任何本地網絡
Calls could not be connected to any local network

量度日期 Measurement Date:
二零二一年三月
March 2021
