船灣淡水湖郊遊徑流動電話網絡接收情況

Mobile Network Coverage along Plover Cove Reservoir Country Trail

圖則編號 Plan No. **OFCA/81**
二零一九年六月版 June 2019 Edition

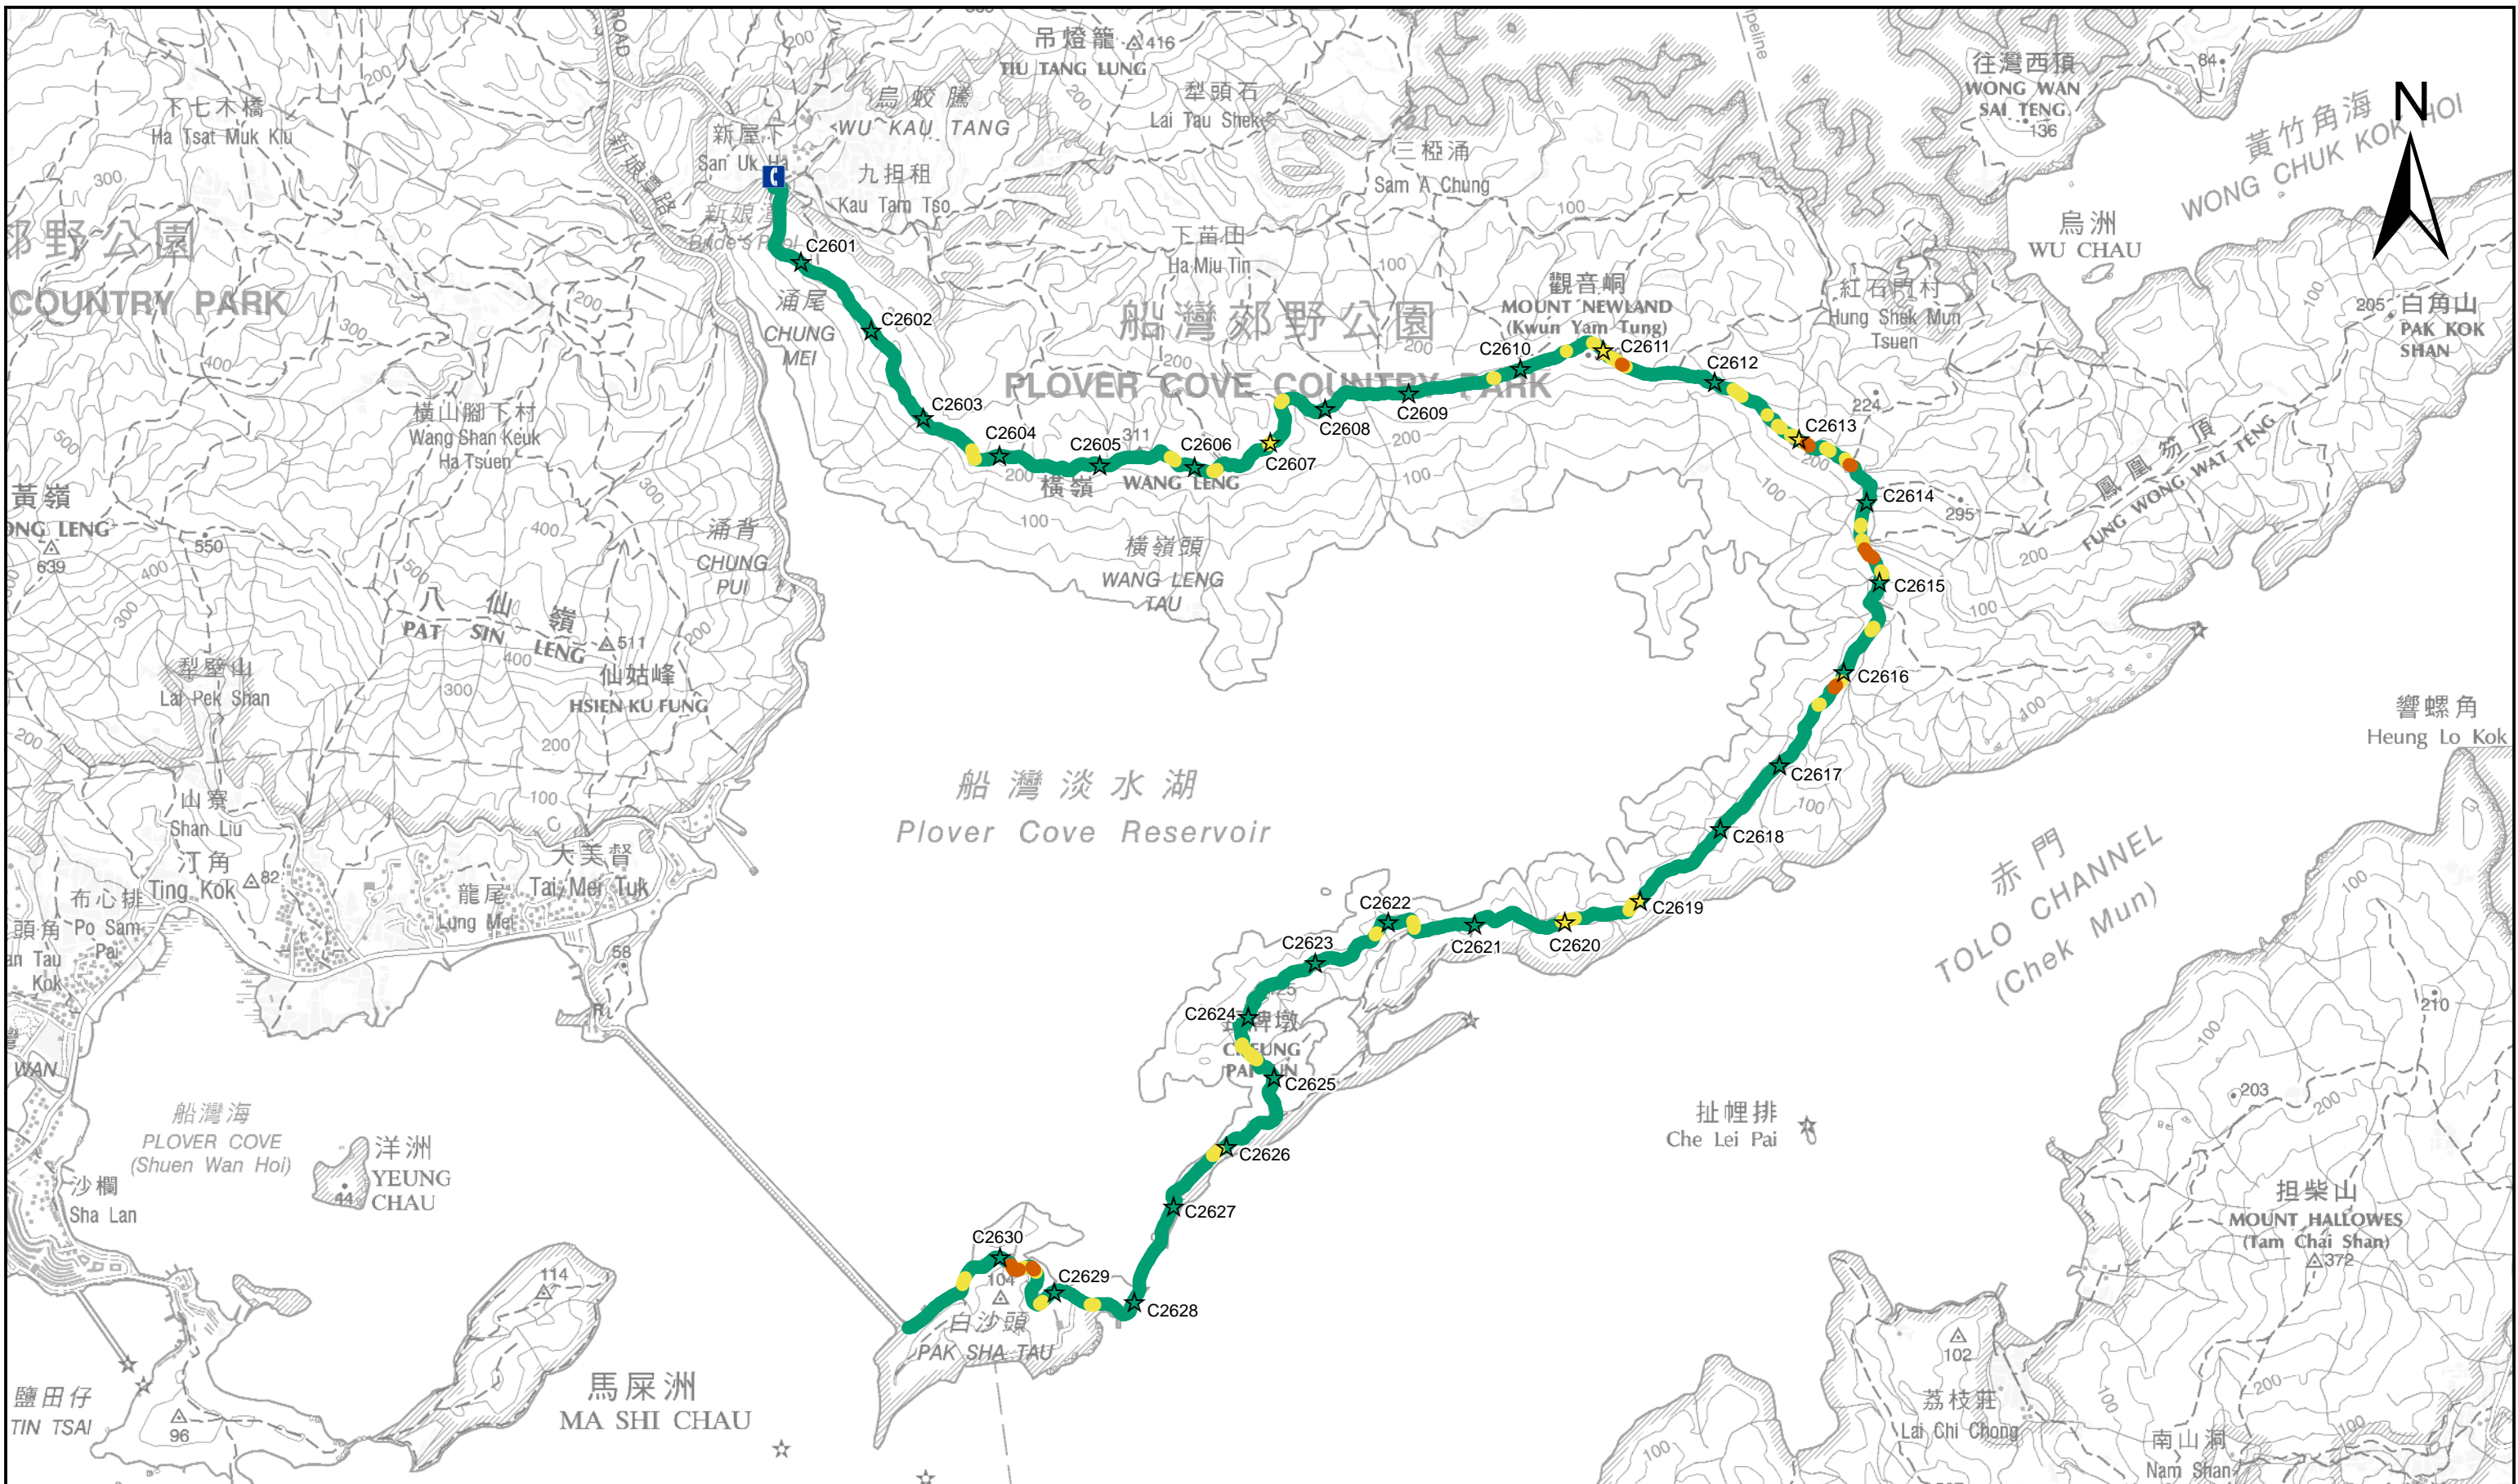
● 可以接駁到一個或以上本地網絡而話音質素良好
Calls could be connected to one or more local network(s) and voice quality was good

● 可以接駁到一個或以上本地網絡而話音質素欠佳
Calls could be connected to one or more local network(s) but voice quality was poor

● 未能接駁到任何本地網絡
Calls could not be connected to any local network

量度日期 Measurement Date:
二零一九年三月
March 2019
